Sensitively Restoring Historic Structures *to Meet Today's* Engineering Standards

BY FRANK MONASTRA, P.E., LEED AP

Restoring the integrity, significance and character of a historic building—while bringing modern-day efficiencies and comfort—can be a lengthy process fraught with challenges, but a completed project is always worth the effort.

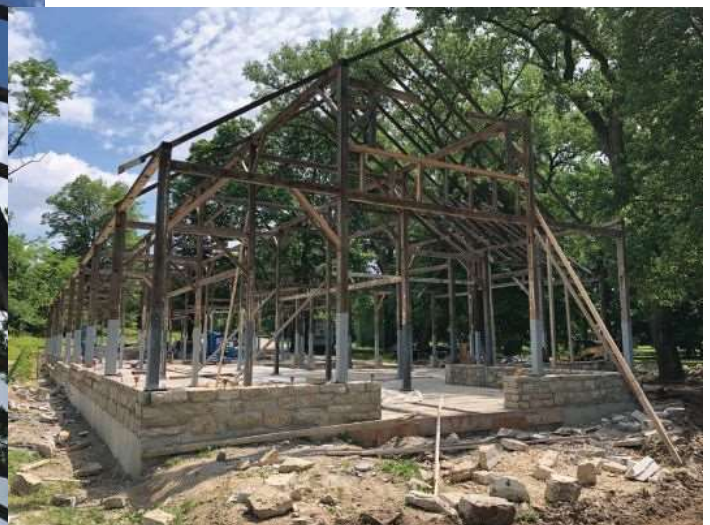
Built in 1901 and located on the original Montgomery County Fairgrounds in Dayton, Ohio, Barn No. 17 has been completely disassembled and rebuilt a little more than a mile away at its new location in Carillon Historical Park.

Contractors are nearly finished with the relocation and restoration of the historic Barn No. 17 that served as a horse stable since 1901 at the recently repurposed Montgomery County Fairgrounds. The project began in April 2019 as workers completely deconstructed and reconstructed the barn—one plank of wood at a time—at its new location.

Barn No. 17 is a large, true timber-frame structure that served as a support building rather than housing public exhibitions. It served as a place to prepare for the next activity or rest after a long day and was a "silent witness to 120 years of county fairs, races and a whole host of special events," says Brady Kress, Dayton History president and CEO.

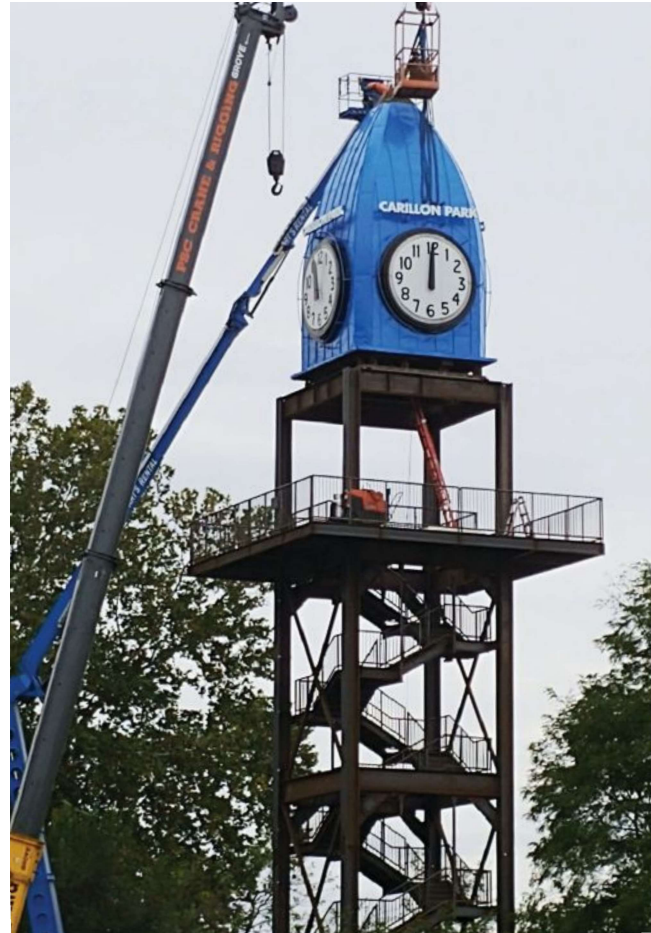
The historic Callahan Clock was built in 1892 and originally located atop Dayton's first skyscraper. The clock was preserved when the building was razed and is now installed atop the Brethen Tower in the city's Carillon Park.

Woolpert provided civil and structural engineering for the 100-foot observation tower with observation viewing available at 75 feet. Funding from the local Brethen Foundation enabled the preservation of a significant piece of local history through the installation of the clock in the park. Kress called the project a dream the organization had since it adopted the clock in 2006.

To determine the design for the tower, Woolpert collaborated with Kress and architect John Roll, president of Roll & Associates, to determine the aesthetics and desired architectural features. Woolpert designed a traditional steel-frame structure using weathering steel material, which develops a protective rust coating and provides an industrial aesthetic. The tower's deep foundation system consists of 12 augercast piles that extend 40 feet into the ground. The steel frame will resist forces generated from a 90-mph windstorm.

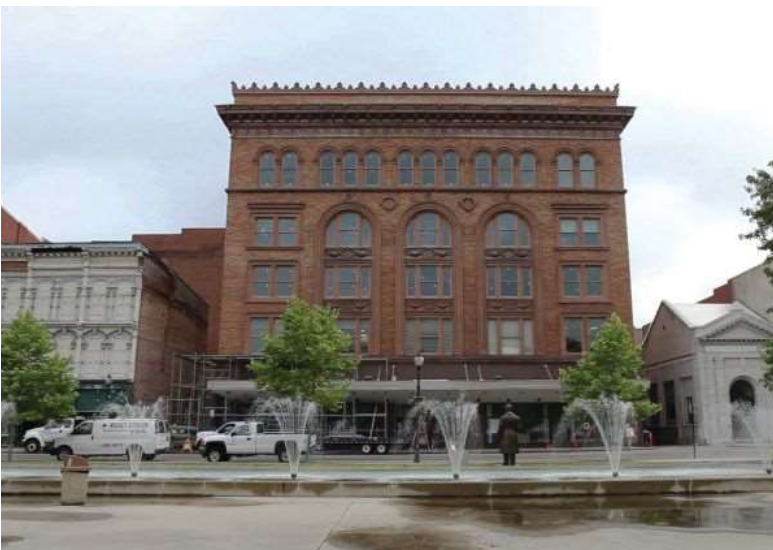
The 150,000-square-foot Bushnell Building in Springfield, Ohio, is among the 95,000-plus structures on the National Register of Historic Places. The building was completely renovated and modernized, earning LEED certification.

When Jim Beck, Woolpert engineering lead, became involved with the project, the building was in poor condition. Beck and the Woolpert team faced the challenge head-on to convert an "energy hog" of a building to meet the LEED concept of not consuming more materials than necessary. The first simple changes, such as enclosing the building to prevent heat loss and improve operations of the building's systems, resulted in energy savings and improved the interior environment for occupants.

Saving energy continued through the installation of ventilation sensors, which bring fresh air into the building whenever carbon dioxide emitted by occupants is detected in a room. Daylight harvesting sensors were installed to turn off LED lights in rooms when there's enough sunlight coming in from windows. In addition, a water-source heat pump recycles waste heat from one part of the building for use elsewhere in the building.

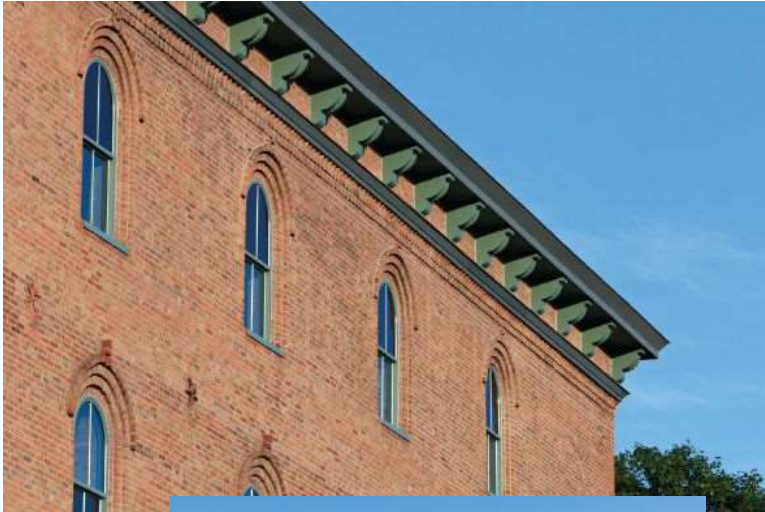
Restoration of the Cerealine Building in Columbus, Ind., built in 1880, transformed the historic structure from an old, dilapidated factory into a beautiful, modern conference center.

Cummins wanted to restore the Cerealine Building for use as a conference center on its campus, but the building had been changed several times through the years. Floor lines didn't match up with windows. The HVAC system from a previous renovation was inadequate for the building and couldn't be repaired. The roof was failing.

A key design task was ensuring the look of the building's historic exterior was maintained. New energy-efficient windows matching the original windows—curved at the top with similar panes and mullions—were installed into the same window openings without changing the size or location. The beautiful brick exterior also was preserved. A new roof shored

up the envelope of the building, and a state-of-the-art HVAC system was installed to provide heating and cooling throughout the entire building.

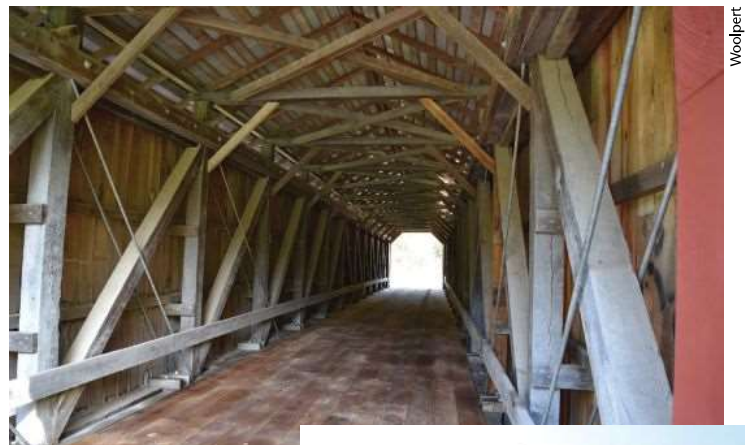
Built in 1886, the Foraker Covered Bridge over the Little Muskingum River near Graysville, Ohio, was completely rehabilitated after its 92-foot span had begun to sag. The work was completed in 2016, and the project earned the Historic Bridge Award as presented by the Federal Highway Administration, Ohio Department of Transportation, State Historic Preservation Office and the County Engineers Association of Ohio.

In 2017, such detailed attention to restoration methods led to Mattox and Woolpert Engineer Tom Less being awarded Ohio's Statewide Historic Bridge Preservation Award for their work on Monroe County's Foraker Bridge, built in 1886. A previous restoration project left the 92-foot-long bridge sagging 11 inches.

While historic restoration is a goal, meeting modern safety standards means installing steel rods under the floor to help carry heavy loads, shifting from wooden shingles to metal sheeting to decrease weight, and spraying fire retardant over the interior of the bridge.
